State and Federal Safety Obstructions on Water Towers

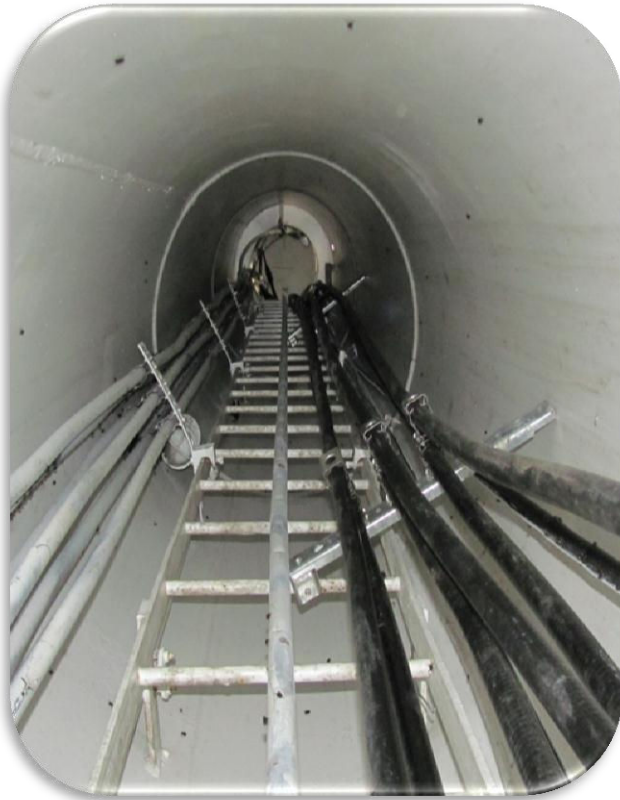
Photo 1 (a cellular company has installed cables on the side and face of ladder)

A high percentage of water towers have cables or conduit fastened directly to access ladders. Devices installed on any portion of a ladder may be defined by MO DNR and OSHA as safety obstructions, thus violating State and Federal regulations (see Table 1). Poor installations range from telemetry cables to bundles of cellular cable fastened to areas of ladder (see Photo 1). Per code outlined in Table 1, the welded ladder stand-off brackets may be regarded as an integral component to the ladder, rendering the area equivalent to obstruction codes (see Photo 2). Further addressing stand-off tab areas, OSHA codes further define a seven inch obstruction free zone around the ladder structure.

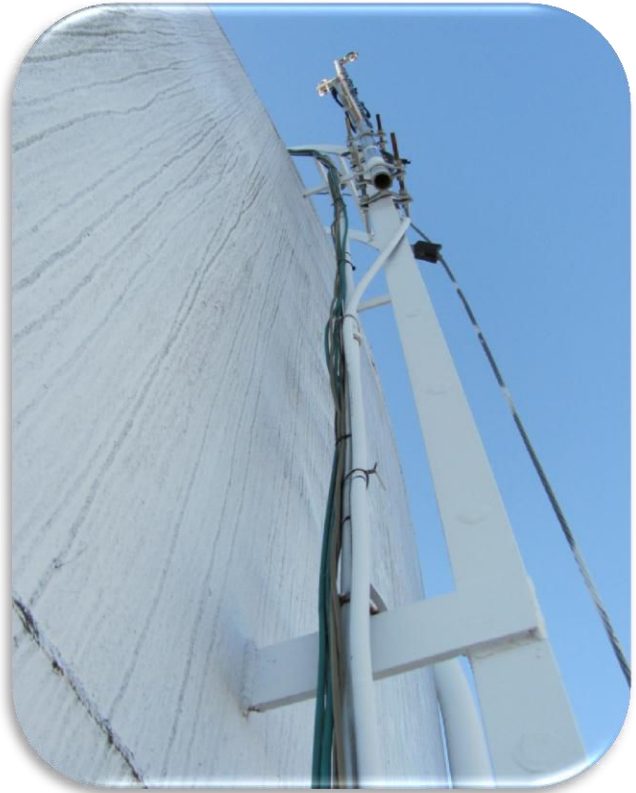
Photo 2 (access ladder with violating cable/conduit on stand-off bracket)

Perhaps revolutionary in thought and supported by code application, the ubiquitous 115 Volt power cable, surrounded by rigid conduit, is no longer appropriate fastened to the stand-off tabs of a ladder. This power cable, when only used for aviation obstruction warning lanterns may be removed and replaced with an FAA equivalent magnetically attached solar powered LED lantern.

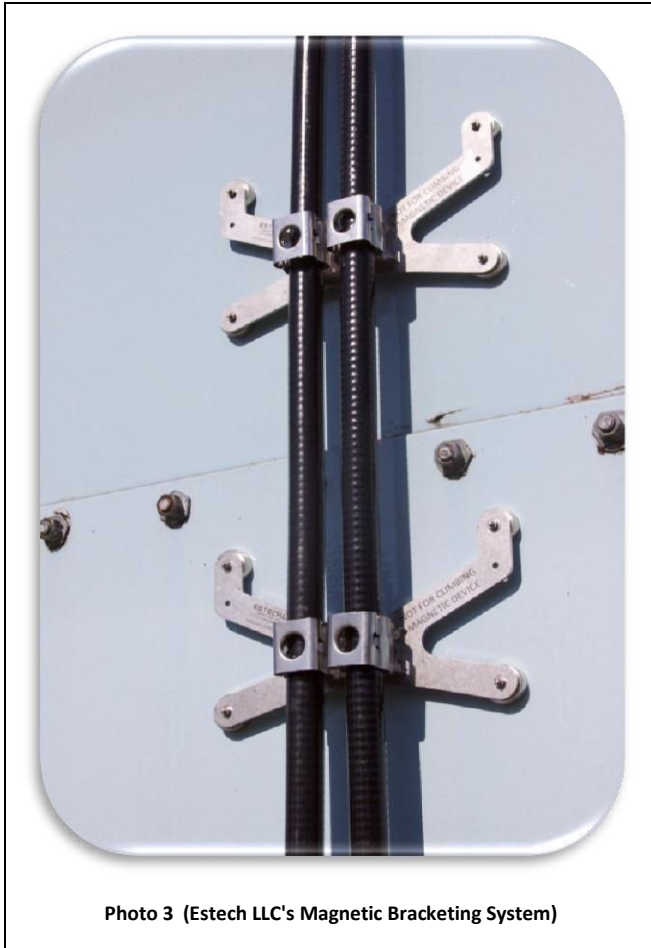
Photo 3 (Estech LLC's Magnetic Bracketing System)

This method is new to most tower owners and has been in use since 2011, with over 7,000 brackets installed. This system is MO DNR approved for use. High strength rare-Earth magnetic fixtures are capable of holding a wide range of cables, including a cellular and wireless cable bundles. They have survived yearly cycles of rain and snow while also having proven successful against tornado force winds and .An important aspect is the ability of attaching to any diameter of steel curvature, convex or concave. Fully adjustable and removable, useful during tower maintenance renovations.

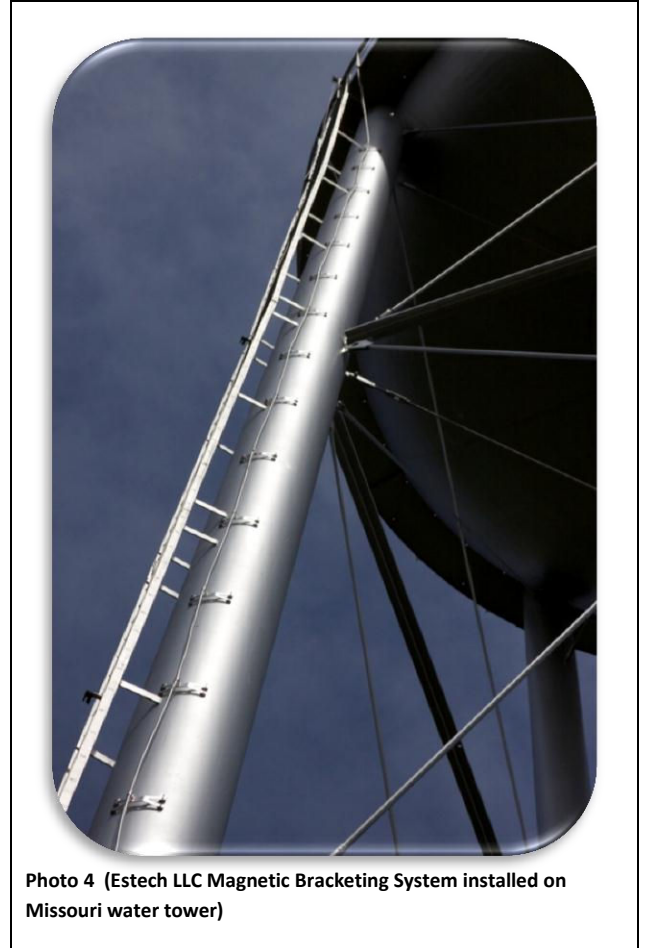
Photo 4 (Estech LLC Magnetic Bracketing System installed on Missouri water tower)
