# State and Federal Safety Obstructions on Water Towers

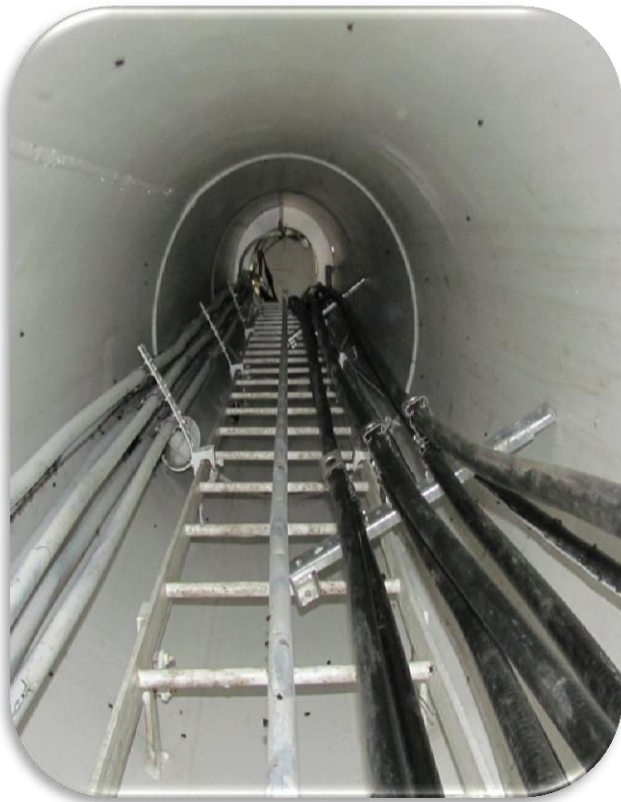
**Photo 1** (a cellular company has installed cables on the side and face of ladder)

A high percentage of water towers have cables or conduit fastened directly to access ladders. Devices installed on any portion of a ladder may be defined by OSHA as safety obstructions, thus violating State and Federal regulations (see Table 1). Poor installations range from telemetry cables to bundles of cellular cable fastened to areas of ladder (see Photo 1). Per code outlined in Table 1, the welded ladder stand-off brackets may be regarded as an integral component to the ladder, rendering the area equivalent to obstruction codes (see Photo 2). Further addressing stand-off tab areas, OSHA codes further define a seven inch obstruction free zone around the ladder structure.

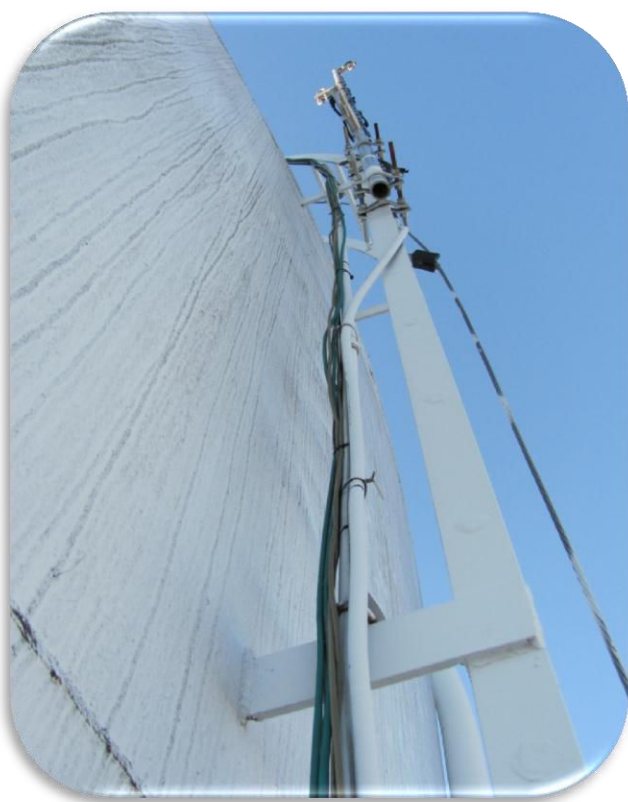
**Photo 2** (access ladder with violating cable/conduit on stand-off bracket)

Perhaps revolutionary in thought and supported by code application, the ubiquitous 115 Volt power cable, surrounded by rigid conduit, is no longer appropriate fastened to the stand-off tabs of a ladder. This power cable, when only used for aviation obstruction warning lanterns may be removed and replaced with an FAA equivalent magnetically attached solar powered LED lantern.

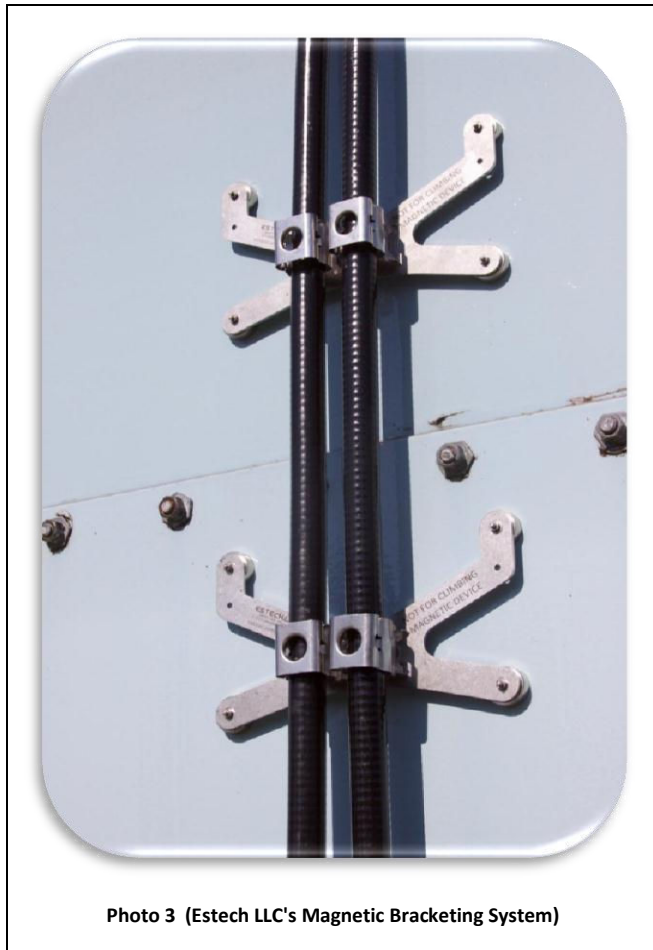
Photo 3 (Estech LLC's Magnetic Bracketing System)

This method is new to most tower owners and has been in use since 2011, with over 7,000 brackets installed. High strength rare-Earth magnetic fixtures are capable of holding a wide range of cables, including a cellular and wireless cable bundles. They have survived yearly cycles of rain and snow while also having proven successful against tornado force winds and. An important aspect is the ability of attaching to any diameter of steel curvature, convex or concave. Fully adjustable and removable, useful during tower maintenance renovations.

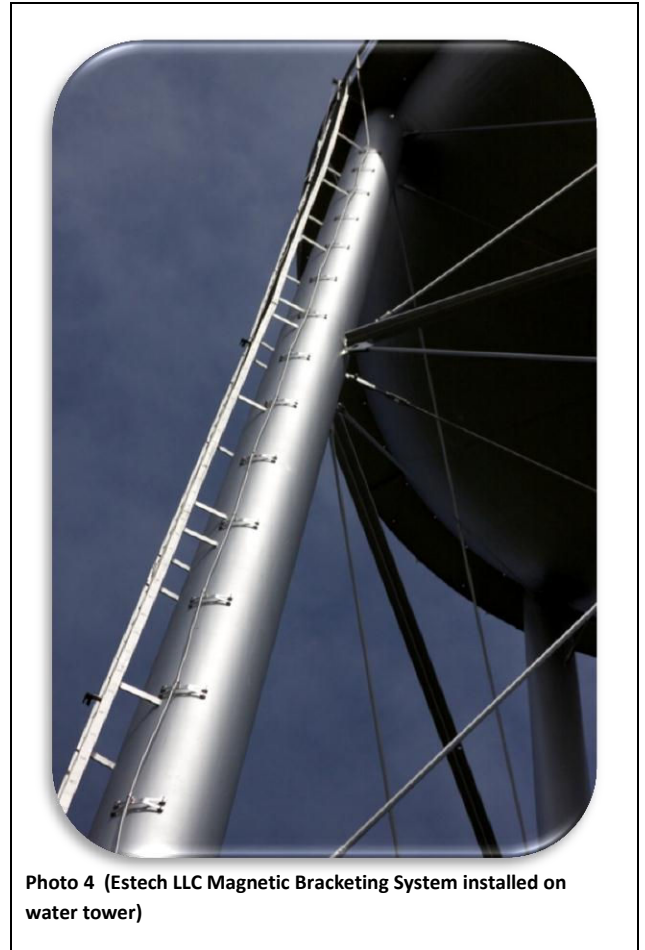
Photo 4 (Estech LLC Magnetic Bracketing System installed on water tower)
