## State and Federal Safety Obstructions on Water Towers

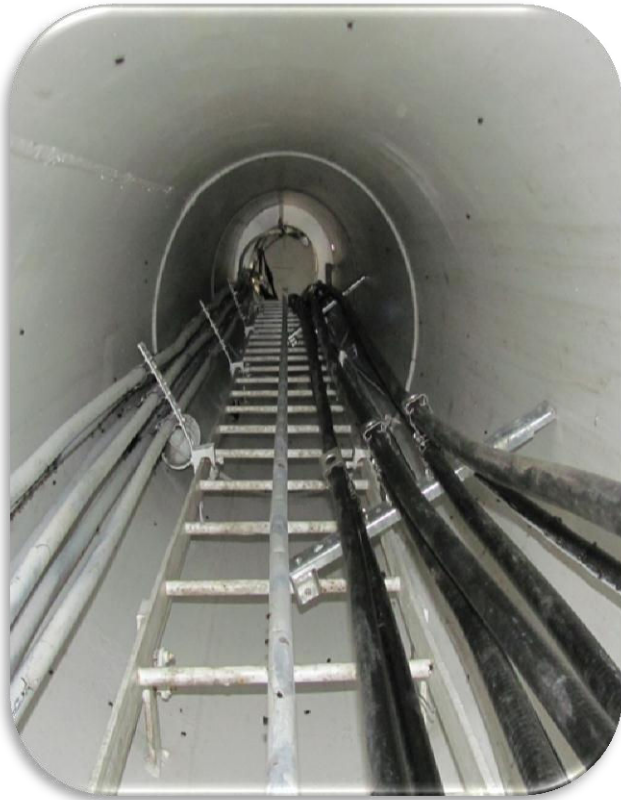
**Photo 1 (a cellular company has installed cables on the side and face of ladder)**

A high percentage of water towers have cables or conduit fastened directly to access ladders. Devices installed on any portion of a ladder may be defined by OSHA as safety obstructions, thus violating State and Federal regulations (see Table 1). Poor installations range from telemetry cables to bundles of cellular cable fastened to areas of ladder (see Photo 1). Per code outlined in Table 1, the welded ladder stand-off brackets may be regarded as an integral component to the ladder, rendering the area equivalent to obstruction codes (see Photo 2). Further addressing stand-off tab areas, OSHA codes further define a seven inch obstruction free zone around the ladder structure.

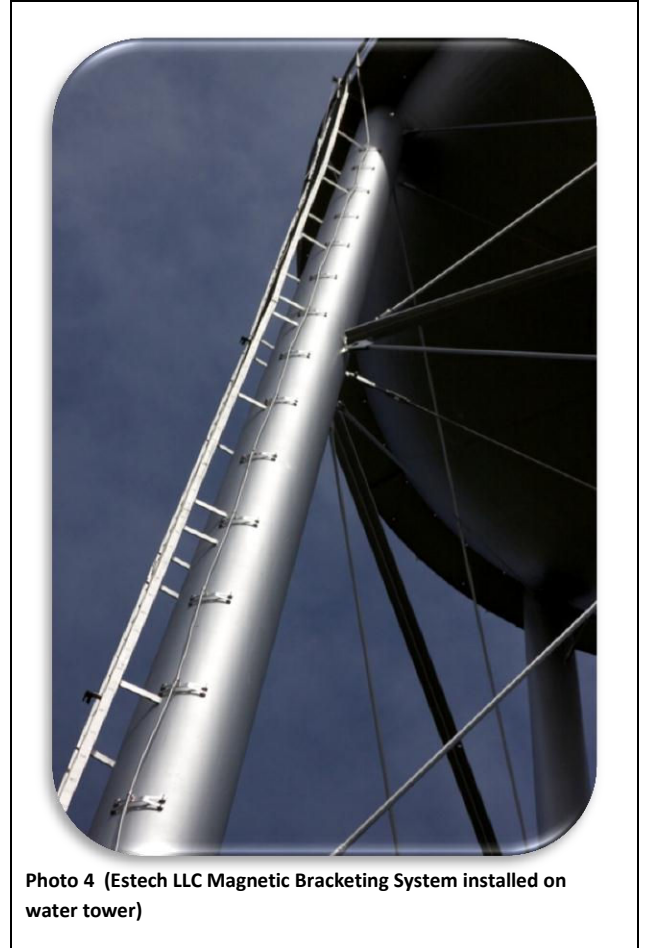
Photo 4 (Estech LLC Magnetic Bracketing System installed on water tower)

This method is new to most tower owners and has been in use since 2011, with over 7,000 brackets installed. High strength rare-Earth magnetic fixtures are capable of holding a wide range of cables, including a cellular and wireless cable bundles. They have survived yearly cycles of rain and snow while also having proven successful against tornado force winds and. An important aspect is the ability of attaching to any diameter of steel curvature, convex or concave. Fully adjustable and removable, useful during tower maintenance renovations.
